Tower Repair & Raising in Remote Locations

An Ampjack® Case Study

This paper explores the successful repair and 10-foot mid-body extension of a lattice tower located in mountainous terrain many miles from the nearest paved road. The project was completed in only 10 working days, without interrupting power, without building access roads, and without bringing in heavy machinery.

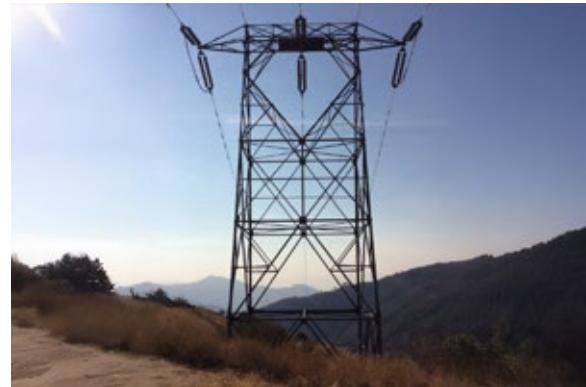
Fig. 1: Remote, mountainous tower location

Tower M213-T1, located approximately two hours from the nearest populated area, sat five miles off the nearest paved road on steep, forested terrain. Inaccessible by traditional vehicles due to downed trees and washed-out access trails, the structure presented a significant logistical challenge even before the full extent of its condition was assessed. (See Fig. 1) An above-ground condition inspection revealed multiple structural concerns:

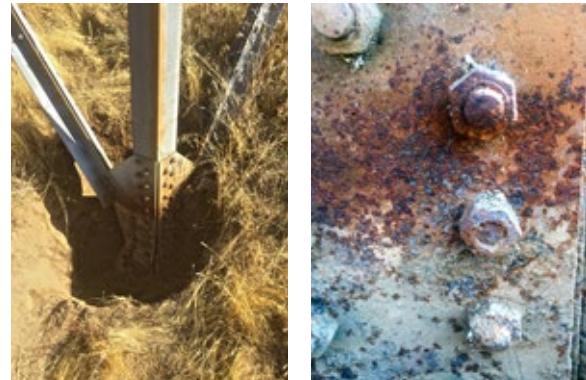
Fig. 2: Corrosion damage

The tower's corrosion score was rated *Poor*, with pitting and below-ground degradation observed at key stress points—including the tetrapod connection. Average pit depth was measured at 0.88 inches, with high-density corrosion clusters recorded. (See Fig. 2)

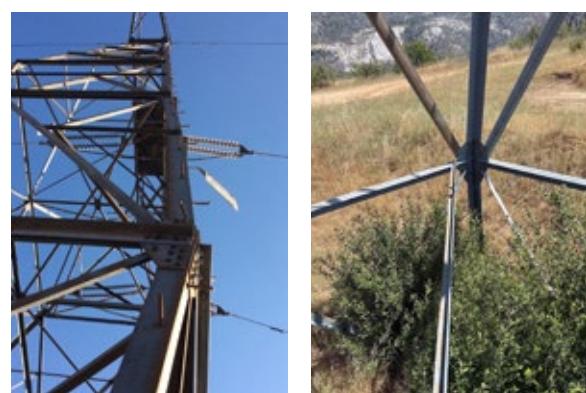
Fig. 3: Bowed leg

Compounding the structural issues, the climbing leg above the extension was bowing, creating a safety hazard that needed to be corrected prior to any lift operations. The surrounding terrain was thick with poison oak, uneven footing, and the documented presence of poisonous snakes, which posed a legitimate risk to field crews. These environmental hazards demanded meticulous advance planning and site-specific safety briefings. (See Fig. 3)

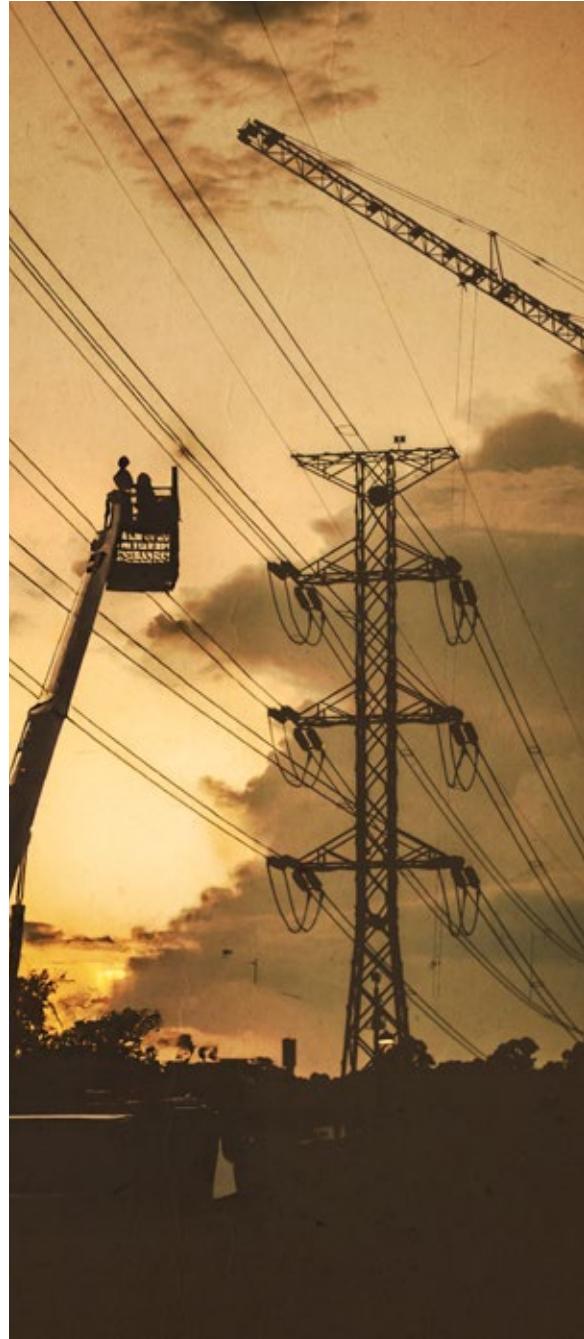
Fig. 4: Traditional tower repair with required outages and heavy equipment

Historically, transmission tower repairs of this scale—especially those involving bent or corroded members, tower leg replacement, or height extensions—have relied on methods that require full power line outages, heavy machinery, and extensive ground access^{3,4}.

1. **De-energize the line**, requiring complex scheduling, permitting, revenue loss, and coordination with system operators.
2. **Build temporary access roads** to transport excavators, cranes, or manlifts to the site—sometimes through protected or sensitive environments. (**See Fig. 4**)
3. Stage **heavy suspended loads** to disassemble or rebuild tower sections from the ground.
4. Commit to **long timelines**, often multiple weeks or months, to mobilize crews, coordinate outages, and complete the repair.

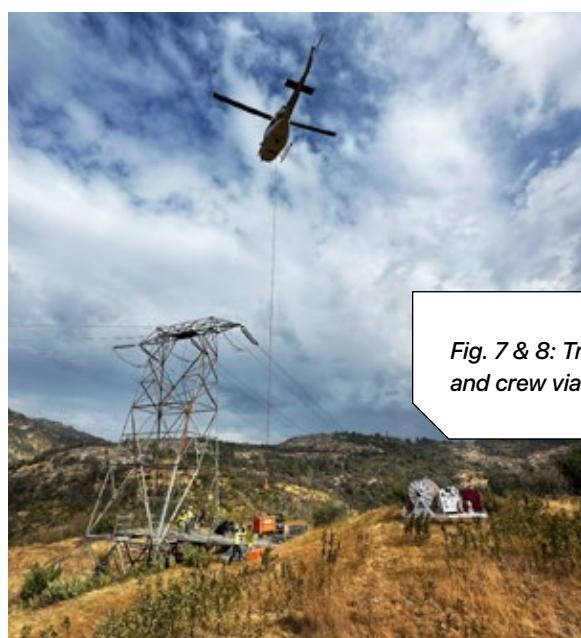
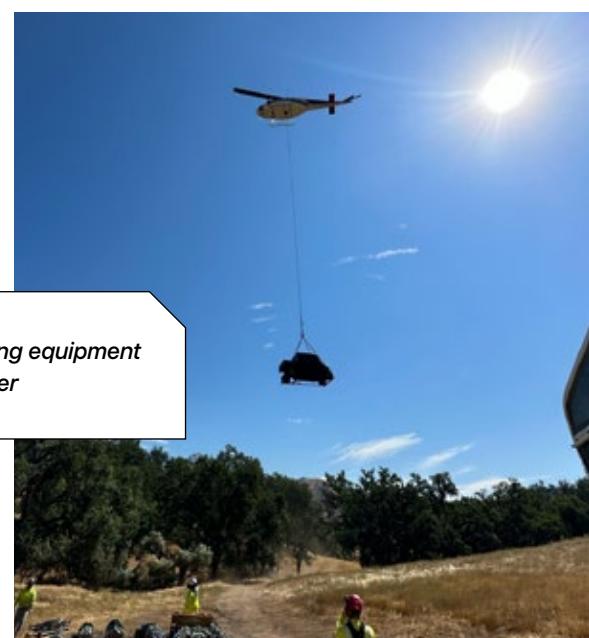
Fig. 7 & 8: Transporting equipment and crew via helicopter

- Access strategy:** Ground access was deemed unsafe and logistically prohibitive. Instead, all tools, equipment, and crew were deployed via helicopter, using human external cargo (HEC) and aerial sling loads to reach the site. (See Fig. 6, 7, 8)
