Keeping the Lights On: Tower Repairs Without Outages

An Ampjack® Case Study

This paper explores the successful structural repairs and upgrades of two lattice towers on a 500kV line owned by a major utility on the West Coast of the United States. The project involved replacing damaged and corroded steel members and restoring the integrity of the tower base — all completed in just 8 days. Crucially, the work was done without taking the line out of service, without using suspended loads, and without exposing workers to the elevated risks typical of traditional repair methods².

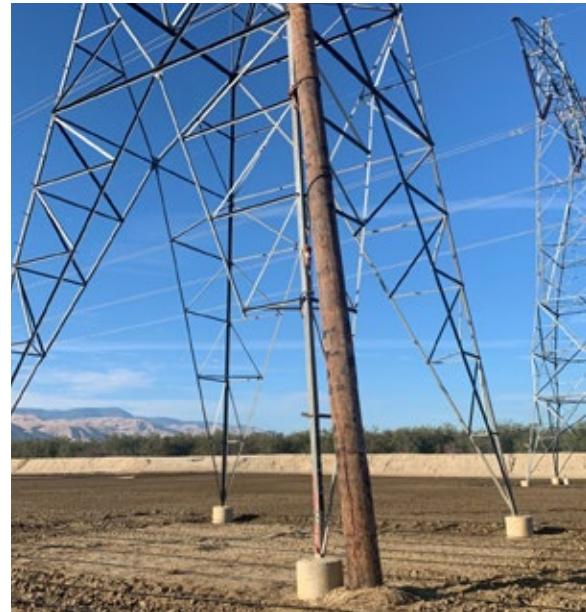
Many transmission towers in use today were built decades ago, requiring upgrades to meet current load and resilience requirements³. Like many aging transmission towers across North America, the two structures in question—designated **M15-T3** and **M36-T2**—had suffered corrosion and structural deterioration over time. Due to damage, M36-T2 was being held up with a repurposed wooden utility pole (see **Fig. 1, Fig. 2, & Fig. 3**). The M15-T3 tower showed significant wear at its base, specifically at the concrete foundations, which had compromised bolted panel connections, and also featured bent beams in the mid-span section (see **Fig. 4 & Fig. 5**). The situation called for urgent intervention to prevent potential failure or further degradation.

Fig. 1: Tower M36-T2 leg held up with wooden pole

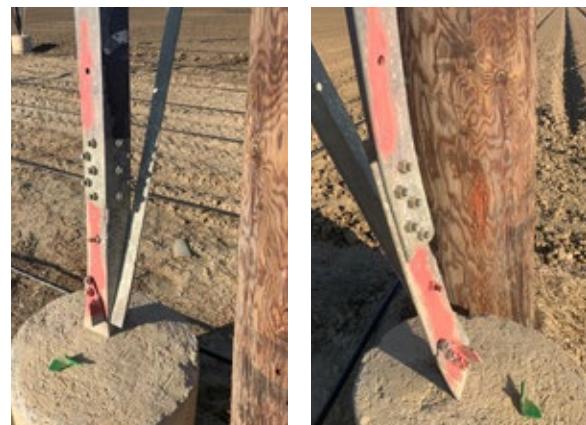
Fig. 2 & Fig. 3: Tower M36-T2 leg damage

Tower M36-T2 presented a different challenge. One tower leg and stub angle were bent and misaligned, and several lattice members were compromised (see Fig. 8). Legacy repair methods would have required de-energizing the line, mobilizing cranes to support the tower, and carefully dismantling affected members while the structure was suspended. This process exposes workers to additional hazards and often takes weeks to complete.

- **Load transfer and stabilization:** Patented high-capacity clamp assembly and temporary bracing assemblies were installed on multiple tower faces, distributing loads evenly and supporting the tower independently of the damaged leg.
- **Leg and footing reconstruction:** Crews removed the bent stub angle and excavated the upper portion of the footing. A new stub angle was installed, and the footing cap was reconstructed using high-strength concrete, restoring full load capacity.
- **Member replacement:** Redundant members and tension bracing on the A-B and C-D faces were replaced sequentially. The Ampjack system allowed bracing to be reconfigured safely as work progressed, maintaining structural integrity at every stage.
- **System removal and restoration:** After the concrete cured, Ampjack's bracing was removed, and the work area was regraded.

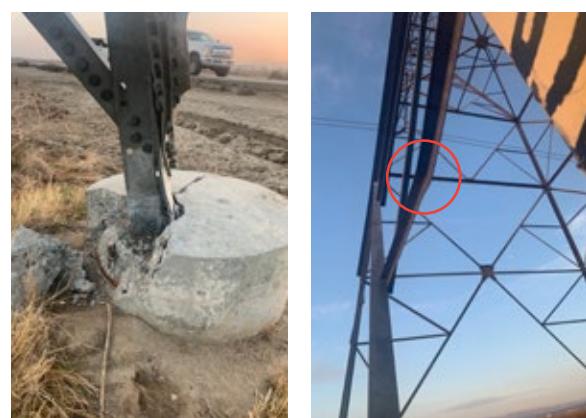
Fig. 4 & Fig. 5: Tower M15-T3 foundation and lattice tower damage

Tower M15-T3 presented two critical challenges: a corroded lower leg section and associated lattice members requiring replacement, and a damaged footing that had to be partially reconstructed (see Fig. 7). Traditionally, addressing these types of failures would require taking the tower out of service, using cranes to suspend and stabilize the structure, and often constructing temporary access infrastructure. These methods introduce significant worker exposure to suspended loads and result in costly service interruptions.

Instead of suspending the tower with cranes, Ampjack used its patented high-capacity clamp assembly supports and hydraulic load transfer system to offload stresses from the damaged leg, creating a secure and stable work environment while the line remained energized.

- **Temporary stabilization:** Crews mobilized pre-assembled patented high-capacity clamp assembly supports and temporary leg bracing to the tower. This system is specifically designed to "grip" the tower legs and foundation without damaging them, transferring structural loads safely and securely.

- **Steel replacement:** With the tower stabilized, corroded lattice members and the damaged stub angle were replaced with new steel sections, all performed without the need for overhead cranes.

- **Foundation reconstruction:** The top section of the concrete footing was excavated and rebuilt using high-strength concrete and epoxy bonding agents, restoring the footing's integrity.

- **Reassembly and curing:** Once new steel and concrete were in place, Ampjack's support system remained until the concrete had cured to its specified strength. Temporary bracing was then removed, and the tower returned to full structural capacity.

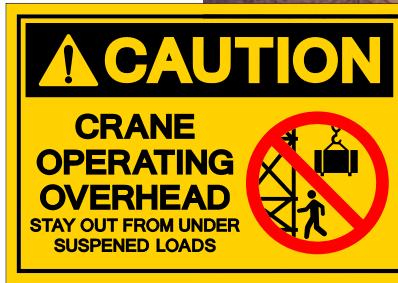
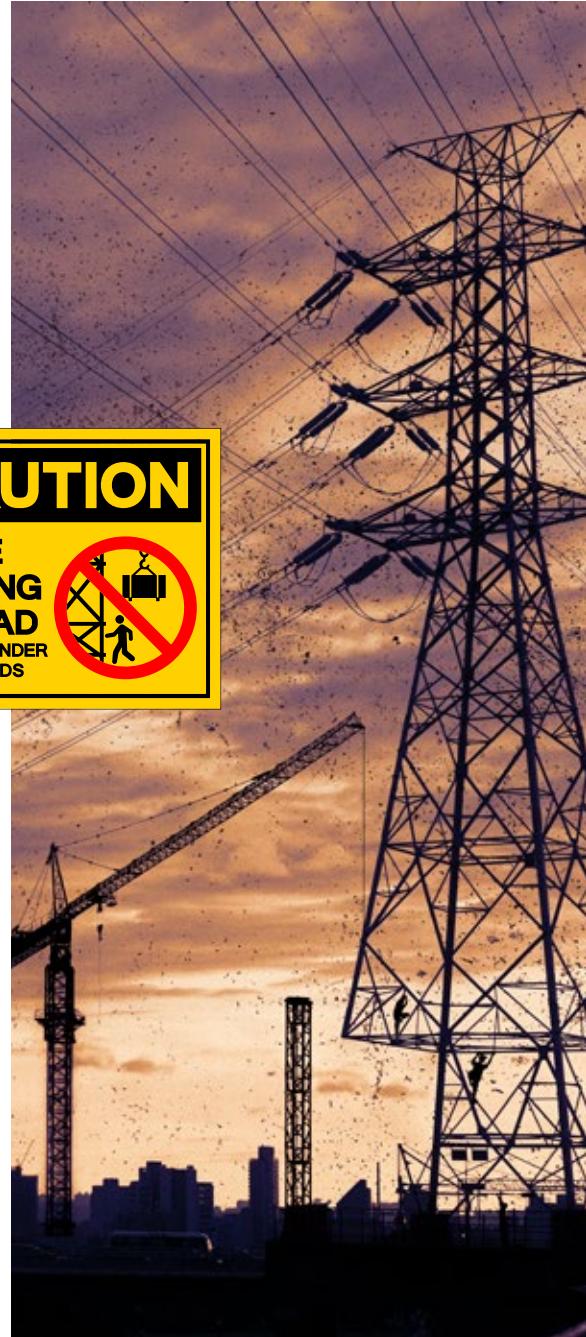
Up until today, utility companies have relied on a standard approach to repairing transmission towers: de-energize the line, mobilize cranes or rigging systems, and suspend critical sections of the tower structure while corroded or damaged members are removed and replaced (see Fig. 6). This method often involves multiple crews, specialized access equipment, and long lead times — not to mention the planning required to take a line out of service without disrupting power delivery to customers.

Fig. 6: Traditional tower repair with required outages and heavy equipment

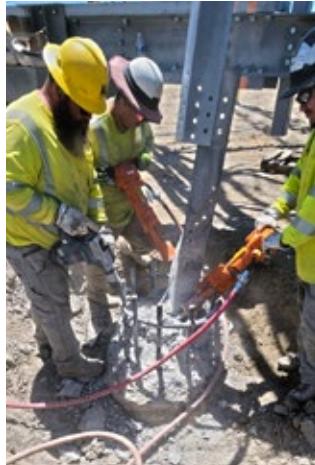
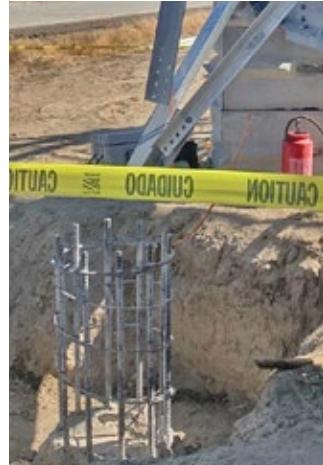
Fig. 11 & 12: Deconstruction and cleanup

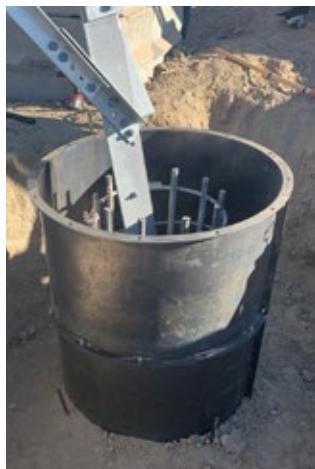
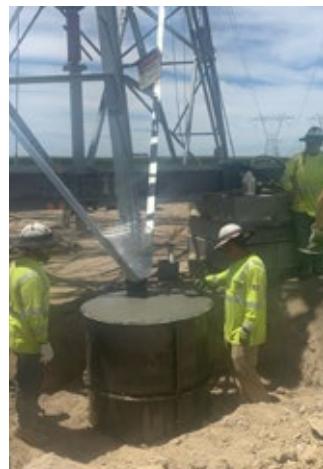
Fig. 13 & 14: New foundation concrete being poured

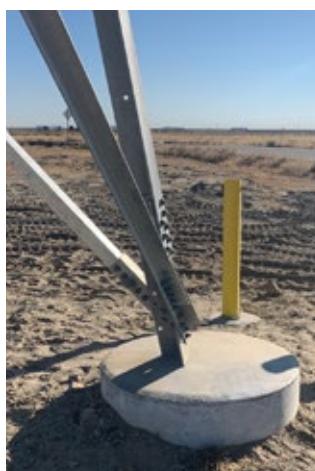
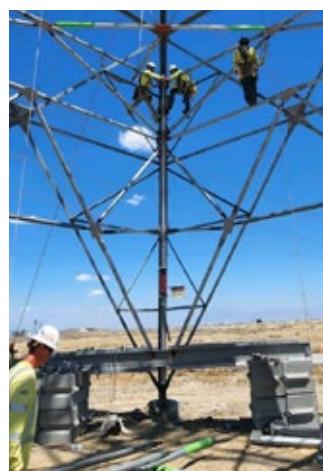
Fig. 15 & 16: Finished foundation upgrades enabling tower work

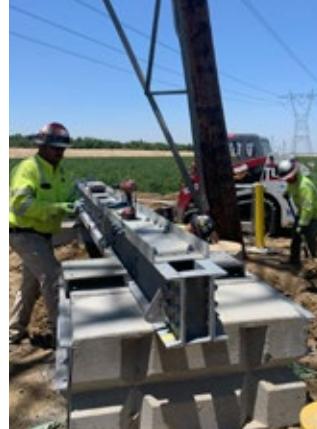
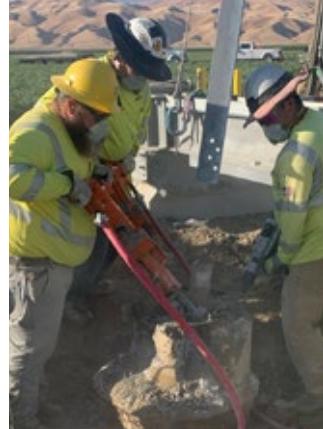
Fig. 17 & 18: Temporary stabilization, deconstruction

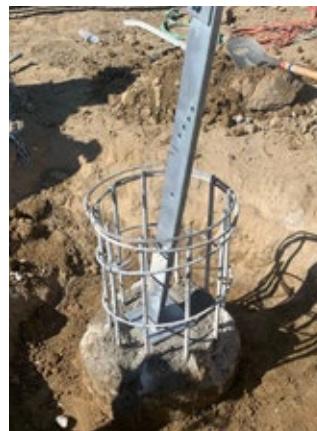
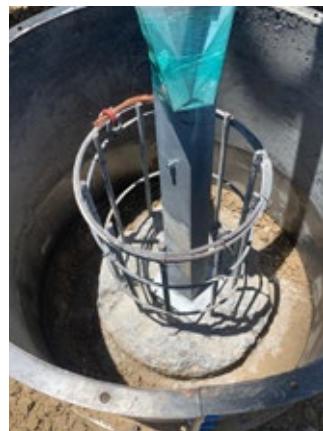
Fig. 19 & 20: Repaired leg ready for new foundation

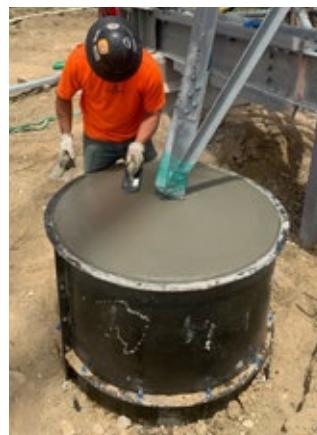
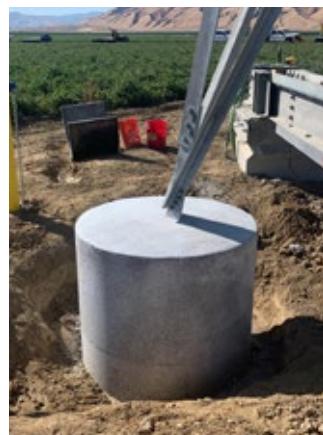
Fig. 21 & 22: New foundation poured and finalized
